2014 ICOMOS-ISCS
International Conference

Proceedings of the International Conference on Conservation of Stone and Earthen Architectural Heritage

Long-term Evaluation of the Conservation State of Marble Statues

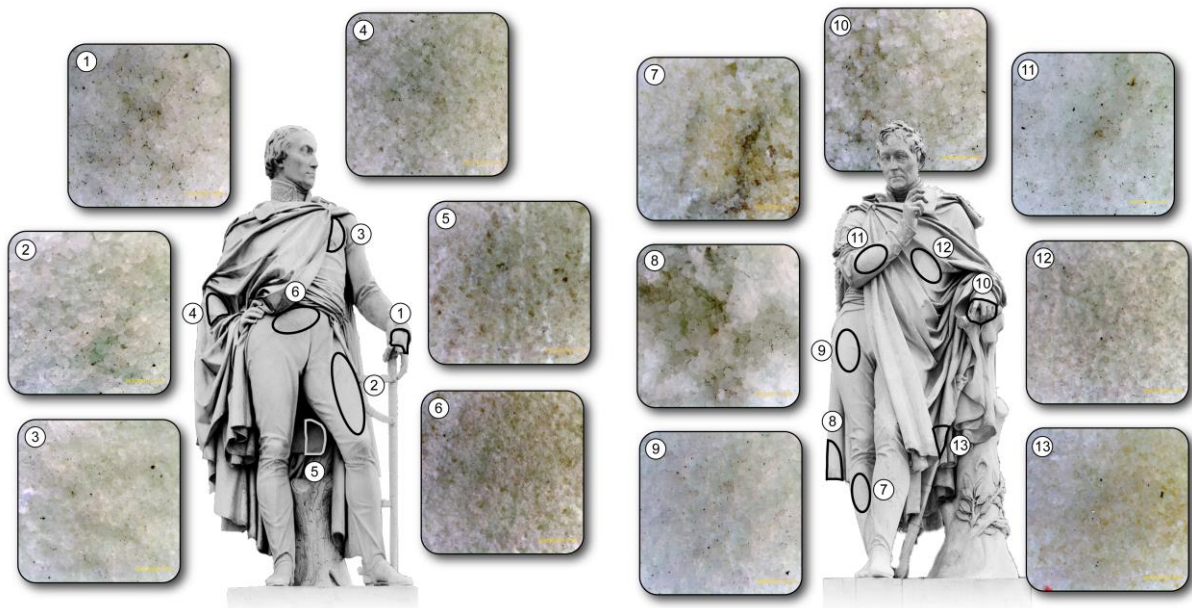
Both sculptures show similar forms of weathering. These include the crumbling of crystals, disintegration, relief formation, and discoloration combined with microbial growth (Figure 2). The different forms of weathering were mapped during the first monitoring campaign in 2009 by restorer E. Böhme and a conservation action plan developed in 2013. Some of the damage to the surface can be traced back to the unsuitable cleaning campaign in 2005. In general the weathering of marble is caused by hygrothermal stress, solution decomposition, and frost bursting (Rüdrieh 2003).

The surface hardness ranges between 291 and 564 HLD. Most values of surface hardness of the tested areas (1, 3, 5, and 6) show a good correlation with ultrasonic velocity (Figure 4), and therefore indicate a penetrative loss of strength also related to surface weathering. The measurements of areas 2 and 4 with around 350 HLD show quite low values of surface hardness but an ample ultrasonic velocity of on average nearly 4 km/s and a classification of II following Köhler. This area of the original surface is well protected against direct wind and rain but the crystal structure is weathered (Figures 2[2, 4]) and 4).

Figure 2. The surfaces of both marble statues show different conditions: 1) separation of crystals and formation of a relief, 2) weathered surface showing single crystals and a low relief formation, 3) moderate weathering, 4) moderate weathered area with microbial growth, 5) and 6) low weathered, nearly intact area with dirt deposits, 7) and 8) strongly back-weathered area with microbial growth, 9) moderately damaged surface, 10) separation of crystals by weathering and formation of a relief, 11) moderately weathered area, 12) nearly intact area, and 13) weathered surface.

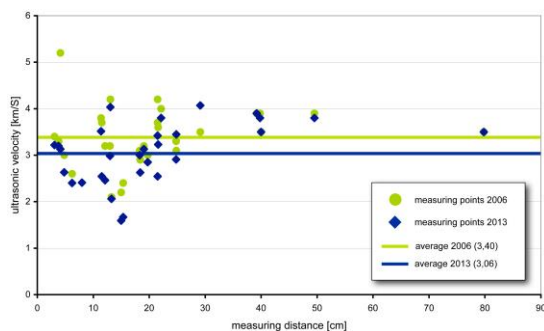
The results of ultrasonic velocity measurements in 2006 showed values between 2.1 km/s and 4.1 km/s. The average value of all measurements is 3.40 km/s. In contrast to 2006, the measurements in 2013 showed values ranging between only 1.6 km/s and a maximum of 4 km/s. The average value reached 3.06 km/s, which amounts to a reduction of 11%. A clear reduction of the ultrasonic velocity could be detected for sections with a material diameter smaller than 20 cm (Figure 3). Most notable is the change of the ultrasonic velocity of the pommel of the sword. This pommel was replaced during the restoration in 2005. In 2006 a value of more than 5 km/s could be measured. Seven years later only 3.13 km/s was detected, which amounts to a reduction of around 40%.

Figure 3. The ultrasonic velocity related to the distance of measurement velocity

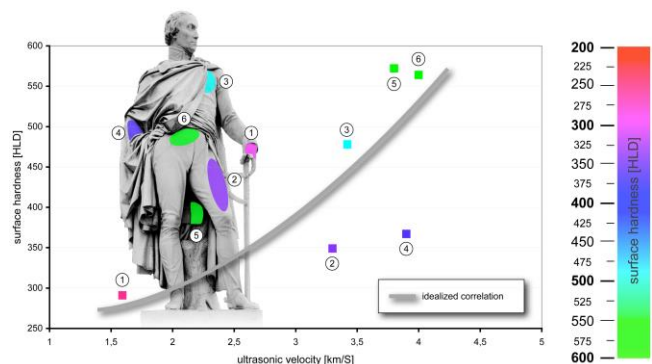
Capillary water absorption, tested by Karsten test pipes only could be detected for area 1. This area has had the lowest HLD values (291) and as well the lowest ultrasonic velocity (1.6 km/s), which means it reached nearly the classification I (disintegration).

Figure 4. The surface hardness correlated with the ultrasonic

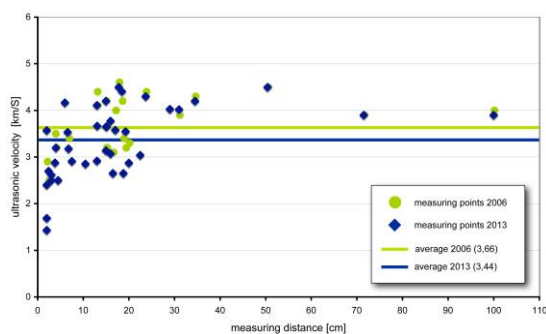
In a first campaign the sculptures were measured by ultrasonic velocity in 2006 after the last restoration. The sculpture show values between 2.5 km/s and 4.6 km/s and are reaching an average of 3.66 km/s. By the comparative measurements in 2013 values between 1.4 km/s and 4.4 km/s and an average value of 3.4 km/s could be detected. This comparative low weakening of the average value amounts to a reduction of 9%.

The highest values between 4.0 km/s and 4.6 km/s could be detected at compact areas such as the trunk of the sculpture. In 2006 as well in 2013 low ultrasonic velocity between 3.0 km/s and 4.4 km/s could be measured on free weathered arms and legs. Following the classification of Koehler, these areas are increasingly porous (II). The lowest values could be detected at filigree details such as fingers and robe folds. In 2006 these areas reached an average value of only 2.5 km/s. In 2013 an average value of only 1.7 km/s could be measured for these areas. The results show clear reduction of the ultrasonic velocity for sections with a material diameter smaller than 30cm (Figure 5). This may be due to a deeper penetrative weathering that developed in the case of the Scharnhorst sculpture, probably because the sculpture was exposed to weathering 27 years longer than the Bülow sculpture.

Figure 5. The ultrasonic velocity related to the distance of measurement.

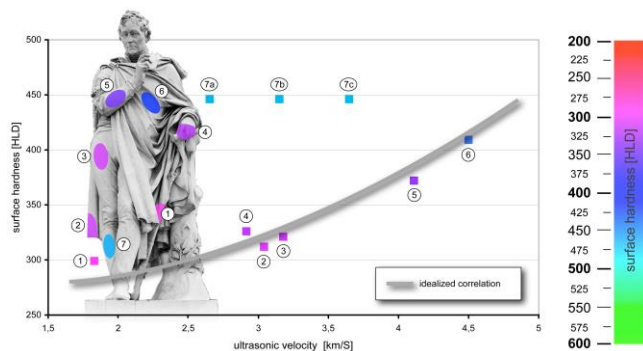
Surface hardness varies between 300 and 450 HLD. Nearly all values of surface hardness measurements show a good correlation with the ultrasonic velocity (Figure 6). This indicates a relation of the lost of structural and surface strength and supports the thesis of a penetrative structural weathering. Only the measurements of area 7 with around 450 HLD show high values of surface hardness but only a medium-sized ultrasonic average velocity of 3.1 km/s. This area of the original surface is water-proofed and still in good condition while the ultrasonic value indicates that a structural weathering has also affected the area.

Capillary water absorption, evaluated by Karsten test pipes could only be detected in area 1. This area has the lowest HLD values (300) and the lowest ultrasonic velocity (1.8 km/s), reaching the classification IV (fragile) following Koehler (Figure 6, Table 1).

Figure 6. The surface hardness correlated with the ultrasonic velocity.

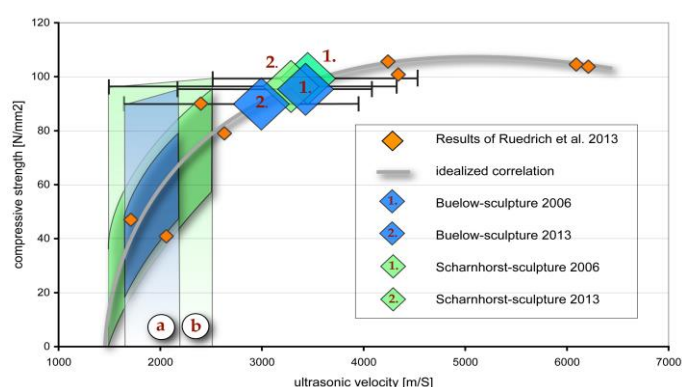
For the investigated samples of Carrara marble in different conditions, in a comparison of samples from both sculptures a compressive strength of 40.89 N/mm² for weathered samples and of 105.52 N/mm² for non-weathered ones could be detected (Rüdrieh et al. 2013). In the cited study the authors also presented a clear correlation between ultrasonic velocity and compressive strength. By fitting the measured values of the ultrasonic velocity into the diagram of Rüdrieh et al. 2013, the average compressive strength of the Bülow sculpture can be determined to be around 95 N/mm² in 2006 and 90 N/mm² in 2013. The changes become clearer when looking at the results for filigree parts of the sculpture. For these areas a reduction by half up to a maximum of around 60 N/mm² and a minimum of around 30 N/mm² can be assumed (Figure 7[a]). For the Scharnhorst sculpture it looks quite similar: the average value reaches around 100 N/mm² in 2006 and 95 N/mm² in 2013 but the affected filigree details of the sculpture show a reduction even higher than the for the Bülow sculpture (Figure 7[b]). Possibly this can be traced back to its sustained period of outdoor exposure over a period of 27 years. The Scharnhorst sculpture was exposed to weathering for 117 years, the Bülow sculpture for 90 years.

Figure 7. The results of the ultrasonic measurements inserted into the diagram of Rüdrieh et al. 2013. The average values of the Bülow sculpture show lower ultrasonic velocity but a lower decrease of stability loss a) than the Scharnhorst-sculpture, b).

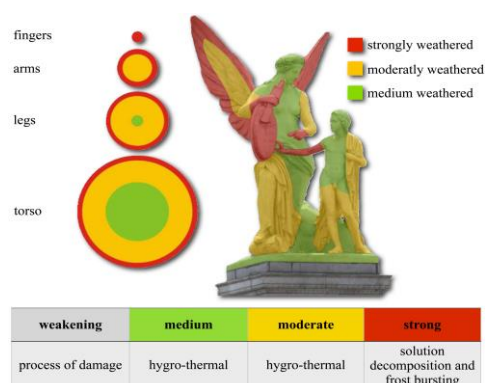
The reduction of compressive strength and loss of material stability seems to be concentrated on the parts with a low material thickness and was presented already as a model as one result of a scientific project to evaluate the state of conservation of the marble statues on the castle bridge in Berlin (Figure 8; Rieffel 2010). The same weathering forms could be observed in the case of the measuring result of both sculptures in this study.

Figure 8. Model of the loss of stability dependent on the object geometry.
